PROPERTY INSPECTION  
**REPORT**

**4321 Sample Drive, Cypress, TX 77429**

DATE OF INSPECTION: 2/21/2022

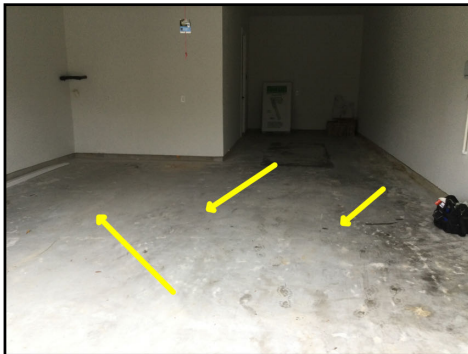
Interior garage surface cracking observed across flooring location(s).

*Interior garage surface cracking observed across flooring locations (Cracking did not appear to have any bearing upon foundation performance during this inspection. Recommend monitoring for future performance)*

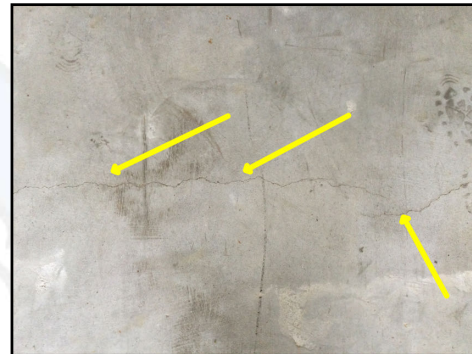
*Interior garage cracking observed across flooring surface.*

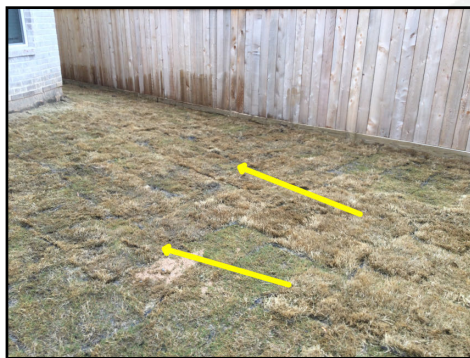
Water settling area(s) observed along one or more location(s) @ time of inspection.

*Water settling observed along back left swale*

**Note:** Area(s) should be evaluated by a licensed landscape and/or irrigation (if applicable) contractor. Landscape contractor(s) should determine if additional drainage system and/or reworking of swales are needed to eliminate settling areas. Subsurface irrigation system may possibly be leaking, if applicable, across interior confines of lot if system is in place during inspection. Settling areas may be conducive to mosquito breeding

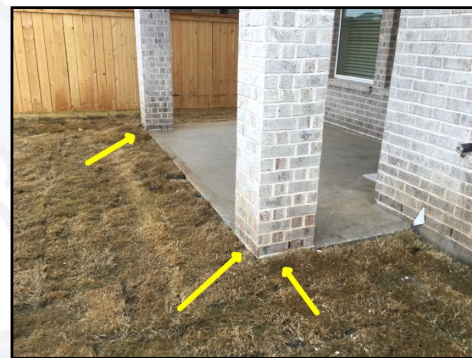
**Soil to brick/siding contact observed along one or more exterior location(s).**

*Soil to brick/siding contact observed along one or more exterior location(s).*

**Note: Soil/mulch bed areas should be lowered to provide a clearance of 4 inches between the surface of the soil and the lower edge of the exterior veneer @ time of inspection. Soil in contact with the veneer allows easy access to the wall cavity and framing to insects. This situation also allows moisture to penetrate into the framing and interior wall coverings and floor coverings. The soil should be graded to prevent water from standing next to the foundation.**

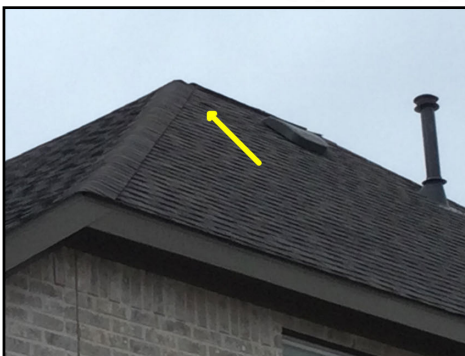
Some shingles appear loose, missing, damaged, curling and/or lifting along one or more exterior location(s).

*Lifted shingle along front right exterior*

**Note:** Shingles should be appropriately set across covering location to eliminate moisture, organic growth and/or other potentially damage across underside of these areas. See picture(s) below.

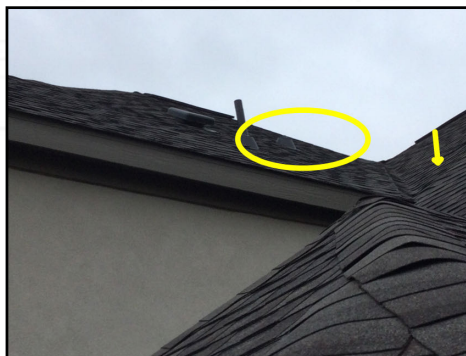
Compromised roofing vents/stacks observed @ one or more location(s).

*(Oval) venting appears to be below standard height over trim at back middle left; (Arrow) Protrusion observed near valley area (Recommend a framing and/or roofing contractor for further evaluation)*

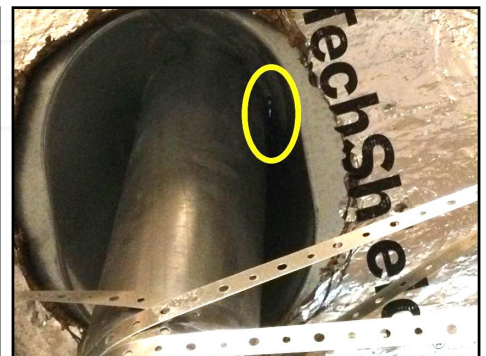
Daylight exposure observed around one or more attic roofing penetration(s).

*Daylight observed around furnace flue piping penetration*

**Note:** Sealing around these penetrations will prevent moisture from seeping around diameter piping, & eliminating moisture from potentially damaging roof decking, insulation, drywall, etc. along interior attic. It is recommended to have all penetrations sealed along exterior prior to acceptance of property. See picture(s) below.

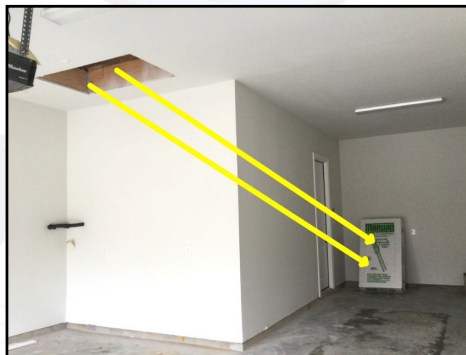
**Exposed opening observed along interior garage attic entrance location.**

*Exposed opening observed along garage attic (Ladder inside box was present along back wall during inspection)*

**Note:** Attic ladder was present inside garage, as proper access way should be installed across attic opening. See picture below.

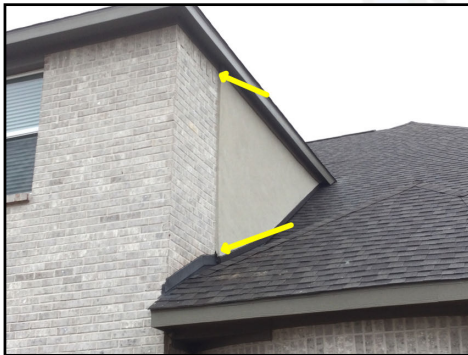
*Exposed gaps observed along back middle left wall (Recommend a stucco contractor for further evaluation)*

The areas between the exterior cladding / veneer and ALL wall penetrations need to be properly sealed such as utility connections, downspouts, hose bibs, lighting fixtures, receptacles, etc.

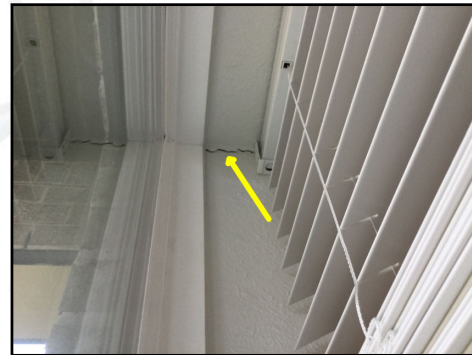
*Drywall cracking observed throughout home (Downstairs living room top area pictured, as client should advise with builder regarding all cosmetic and drywall cracking areas prior to acceptance of property)*

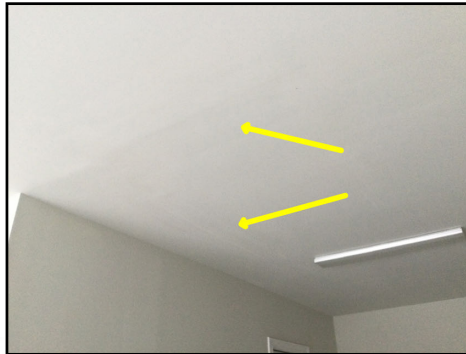
Previous repairs observed along garage ceiling location.

*Previous repairs noted along interior garage ceiling*

**Note: Areas of concern may be from potential leaking and/or drywall repairs from other cosmetic occurrences (ex: settlement) across these areas. All areas affected should be evaluated by client and/or from seller's disclosure. See pictures below.**

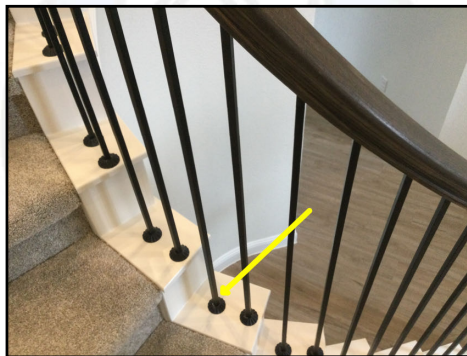
A handrail and/or baluster was observed to be loose and should be corrected as necessary for safety concerns. See picture(s) below.

*Loose baluster observed along handrail location (Recommend securing spindle along location)*

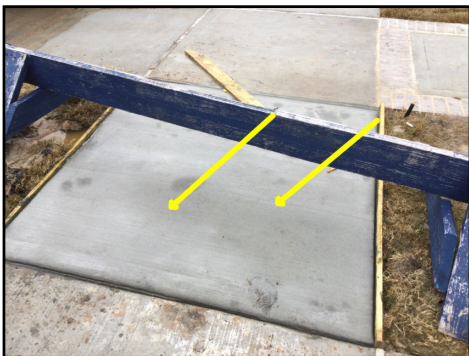
Previous repair noted at front walkway (Footprint noted along edge location)

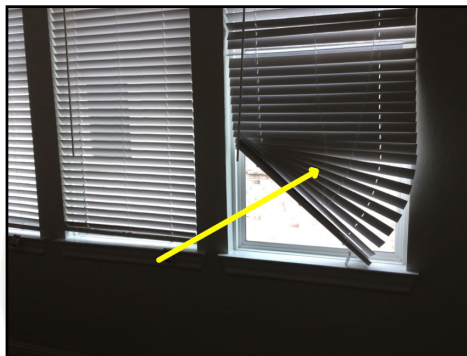
Upstairs game room window blind not functioning properly

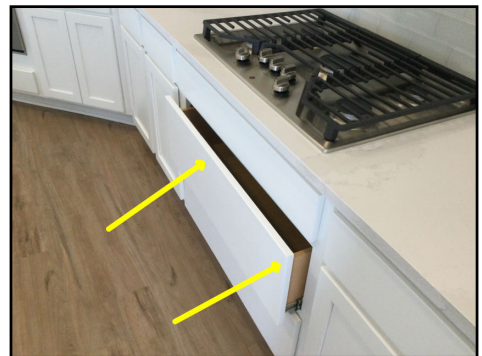
Kitchen cabinet drawer not closing properly in front of cooktop.

Kitchen cabinet not closing properly

**Note:** Cabinets are not part of the inspection, as this appears to be a safety hazard due to the cabinet protrusion. Recommend a cabinet contractor for further evaluation regarding all cabinet imperfections. See picture(s) below.

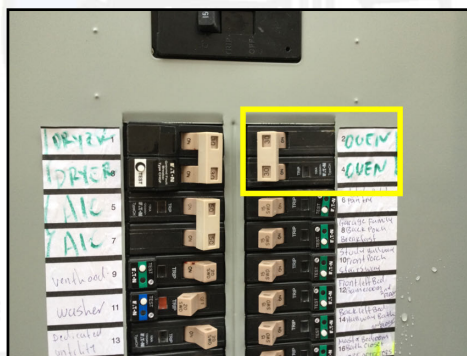
*Oven breaker does not appear to be a GFCI breaker (Recommend an electrical contractor for further evaluation)*

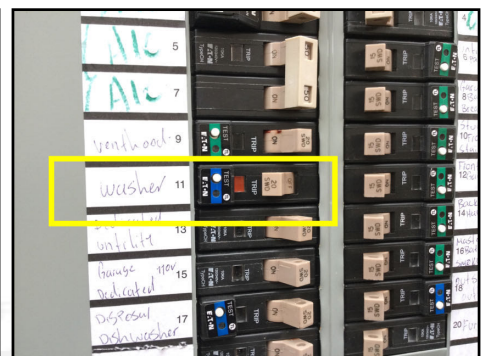
Arc-fault breakers **{AFCI}** did not appear function properly across one or more location(s).

*Breaker labeled for "Washer" does not appear to reset during evaluation*

**Note: Beginning in 2008; AFCI breakers are required in the panel for 15A/20A branch circuits providing power to family rooms, dining rooms, living rooms, libraries, dens, bedrooms, sunrooms, recreation rooms, closets and hallways. ARCI breakers provide fire protection by opening the circuit when an arcing fault is detected. Breaker labeled "Washer" would not reset during evaluation. Recommend an electrical contractor for further evaluation. See picture below.**

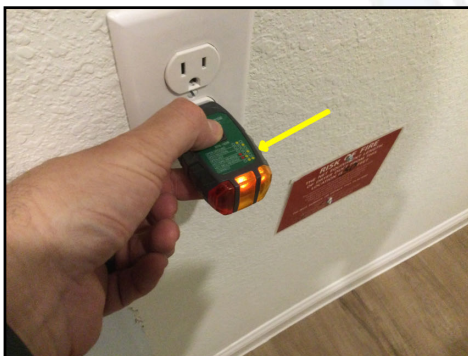
*Utility room receptacle not GFCI protected (Recommend an electrical contractor for further evaluation)*

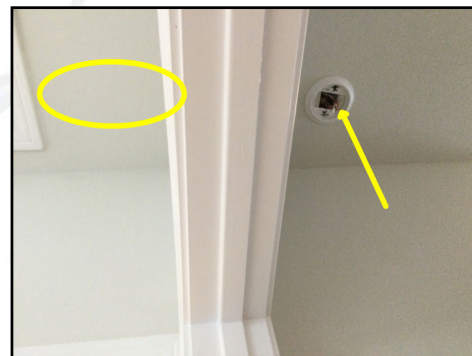
*Smoke/carbon monoxide detector not present at back upstairs bedroom*

**Note: It is recommended that additional smoke & carbon monoxide detectors be installed in accordance with current building standards. The NFPA {National Fire and Protection Agency} recommends one smoke alarm on each level, every bedroom and adjoining hallway per compliance. For additional information regarding detectors, please review the "TEXAS REAL ESTATE CONSUMER NOTICE CONCERNING HAZARDS OR DEFICIENCIES" previous discussed in this inspection report.**

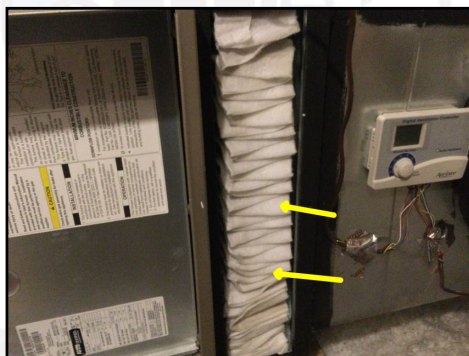
*Filter dirty along media access location*

**Note:** Filters should be changed accordingly with manufacturer's standards. Dirty filters may potentially contribute to dirty HVAC components, causing possible malfunctioning and/or compromising components.

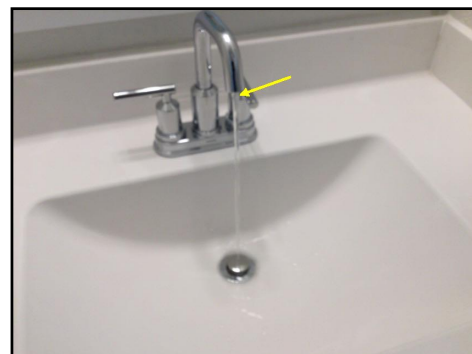
**Water shutoff appears to be located along left interior garage wall**      **Upstairs Jack and Jill sink appears to have low water pressure**

**Note:** Various water sources appeared to have low pressure @ master & hall bath locations. All areas should be evaluated for proper functional flow/pressure across these areas. This should be evaluated prior to acceptance of property.

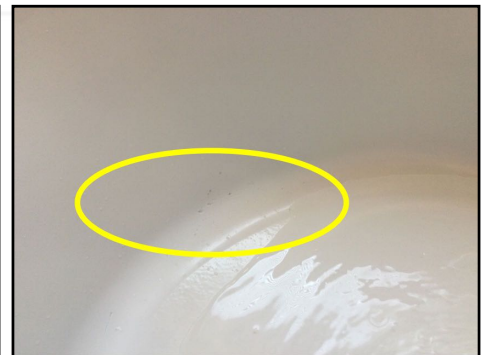
*Gouged observed along interior primary tub*

Note: Area(s) of concern did not appear to penetrate through surface(s) during inspection, as surface areas affected should be evaluated by tub manufacturer and/or other qualified contractor(s). See picture below.

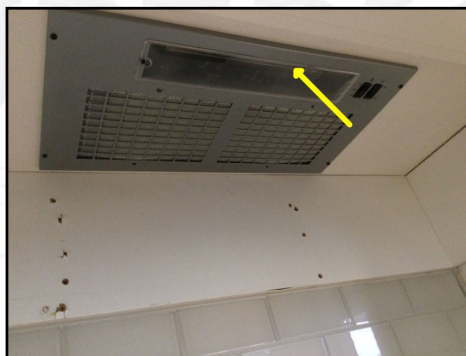
*Kitchen exhaust vent lighting not functional*

**Note: Recommend installation of bulb and/or other evaluations from appliance company if bulb does not illuminate above cook top.**

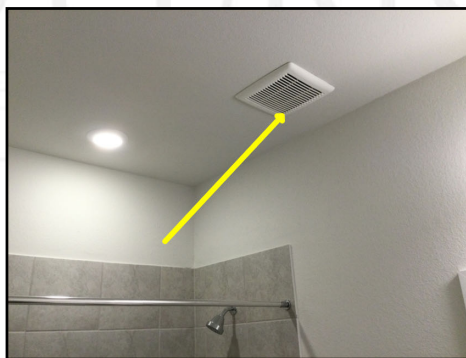
*Unit not functional at upstairs hall bath*

**Note: Recommend an HVAC contractor for further evaluation. See picture below.**

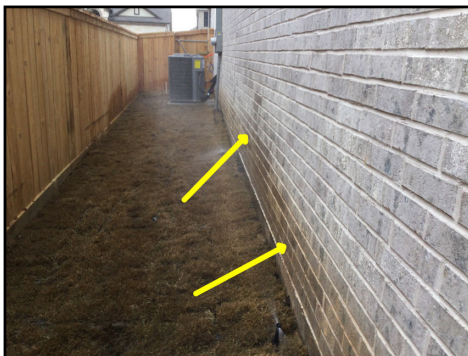
*Various head(s) spraying along exterior walls (Recommend adjustments to spray away from exterior brick wall)*

**Note:** Recommend adjustments to spray off exterior wall location(s).
