PROPERTY INSPECTION
REPORT

17376 Another Street Drive, Humble, TX 77346

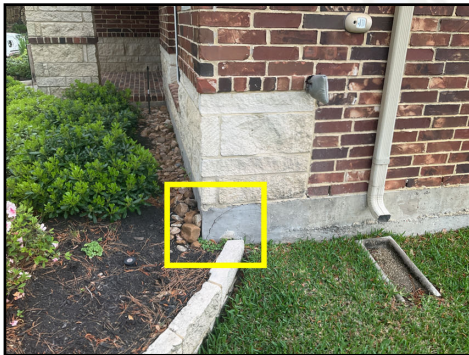
Foundation corner cracking observed along front right exterior

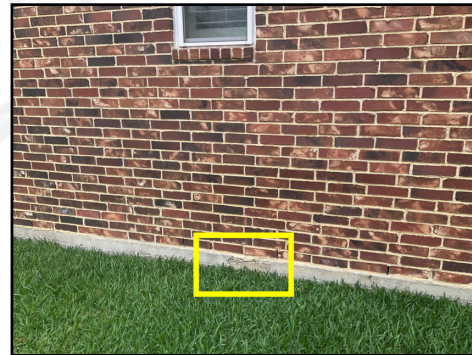
Potential previous foundation repairs observed along one or more exterior location(s).

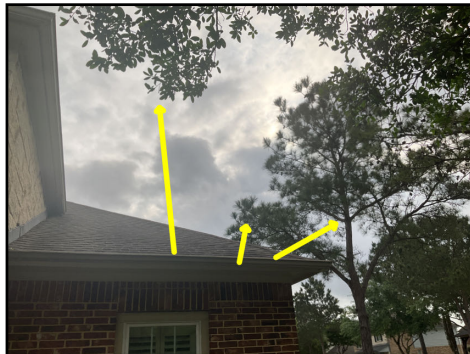
Trees/limbs appear to be close to structure.

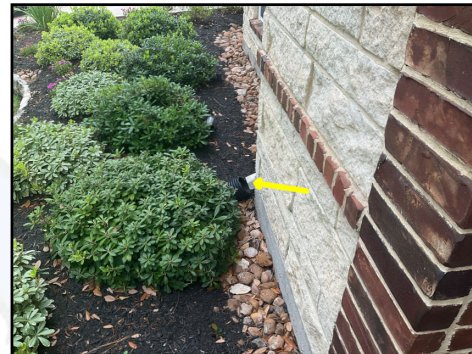
Disconnect observed between front gutter downspout and extension

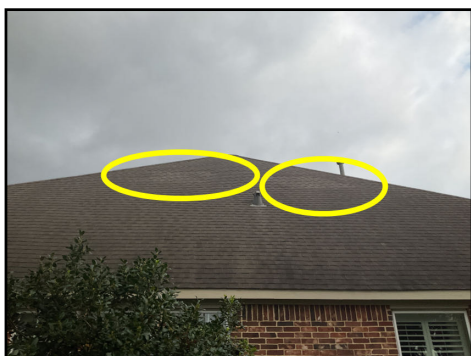
Potential previous repairs observed along right exterior

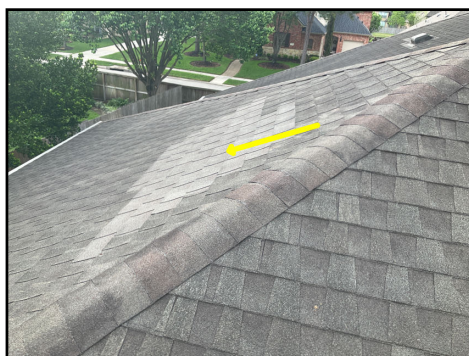
Potential previous repairs observed along back middle exterior

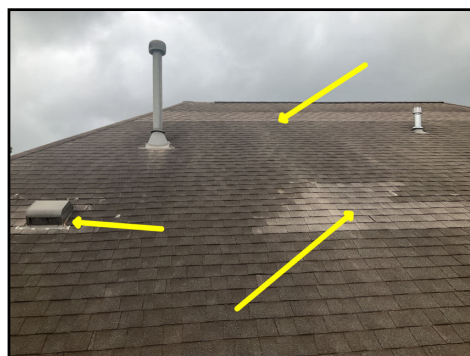
Potential previous repairs observed along back exterior

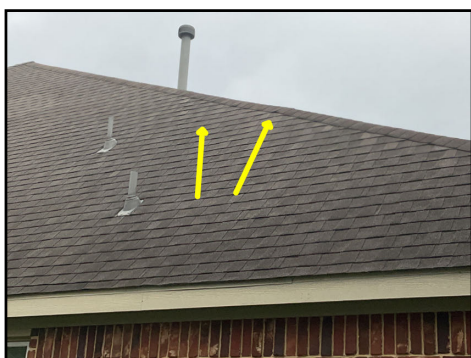
Lifted shingles across several exterior locations

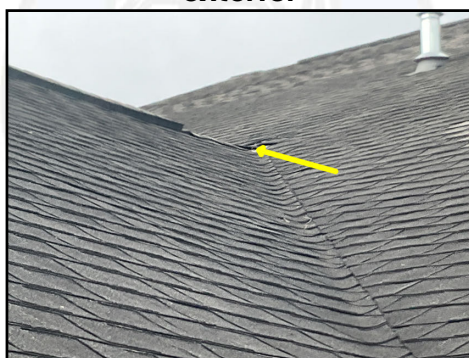
Exposed gap observed along back ridge

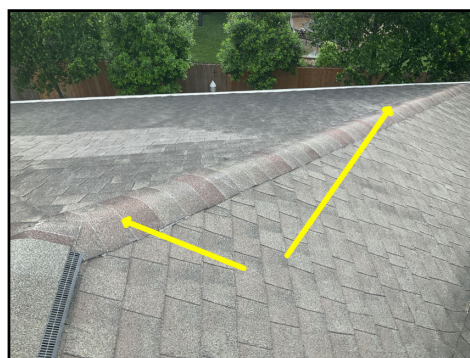
Significant granule loss observed across several shingle locations @ this time.

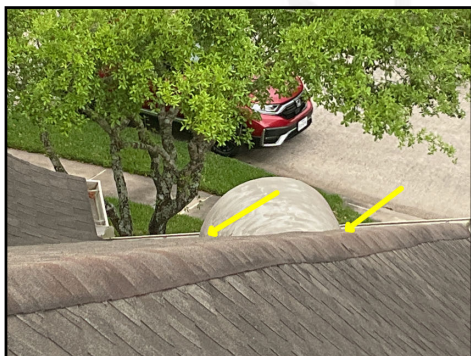
Debris damming observed along left and right connections (Recommend roofing contractor for further evaluation of coverings and all other respective components)

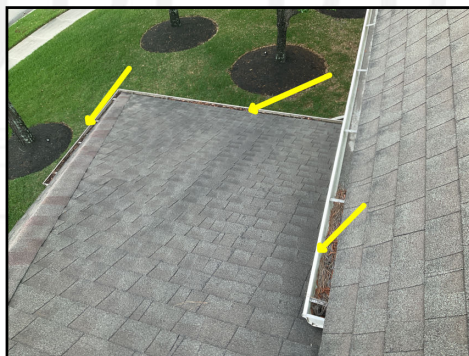
Dirt/debris observed across exterior covering and/or interior gutter system.

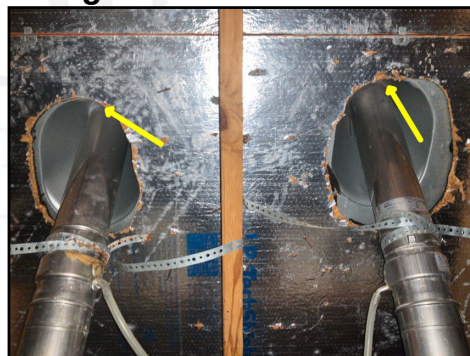
Daylight observed around both water heater flue piping penetrations

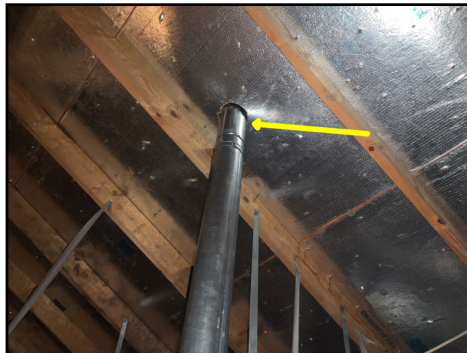
Back exterior furnace flue piping penetration in contact with roofing material

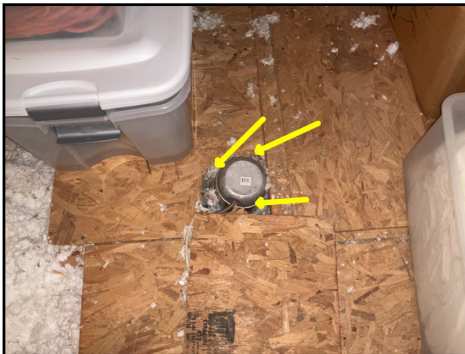
The attic insulation was observed to be covering the recessed lighting fixtures & should be removed from these areas to prevent overheating

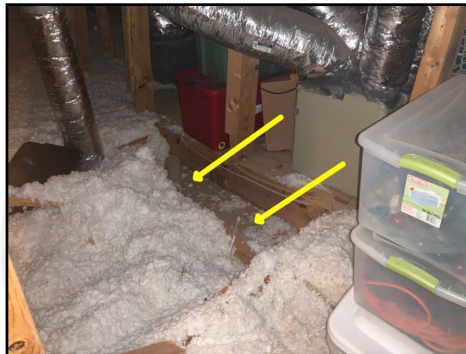
Deficient insulation depth observed at right of attic walkway platform

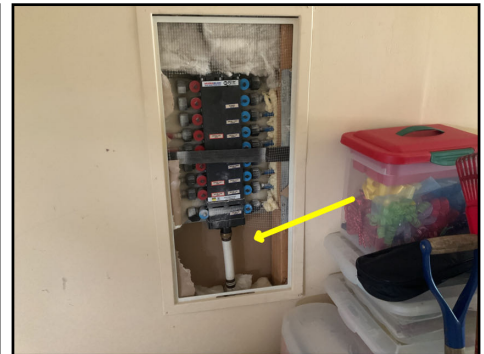
Deficient insulation areas observed along both wall areas behind plumbing manifold

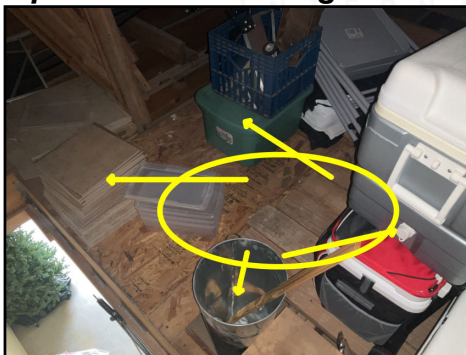
(Arrows) Storage observed across several interior attic areas; (Oval) Unsupported attic landing near opening (Safety hazards observed)

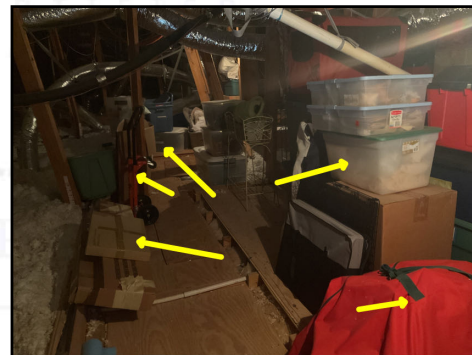
Storage observed across several interior attic locations (Areas below storage were not accessible during the inspection)

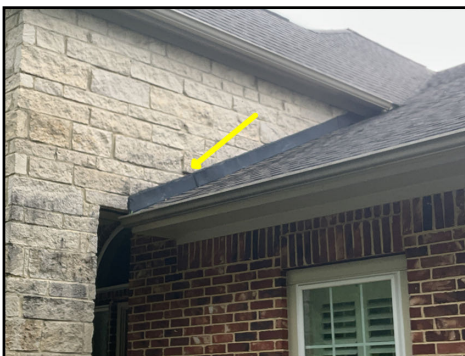
Exposed openings observed along front right exterior porch wall

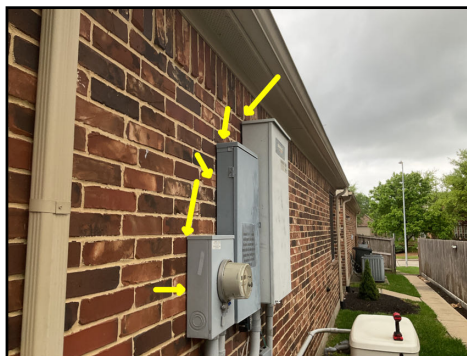
Sealant not present around left exterior electrical boxes

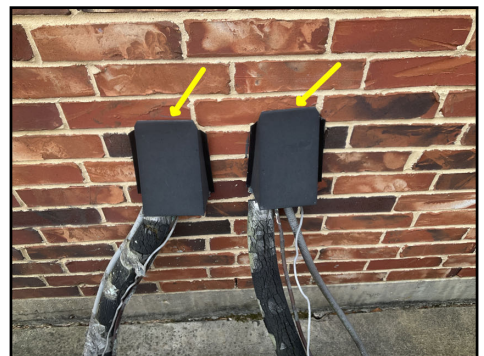
Exposed openings observed around left exterior a/c venting trim

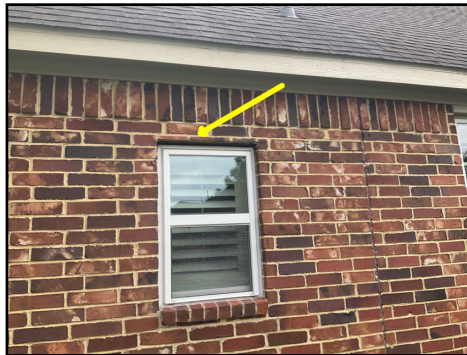
Weep hole(s) not present over right exterior metal lintil

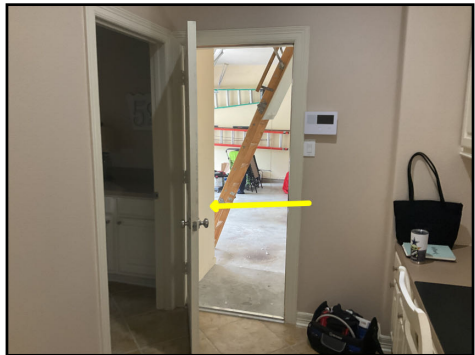
The garage entry door is not equipped with a self closing device.

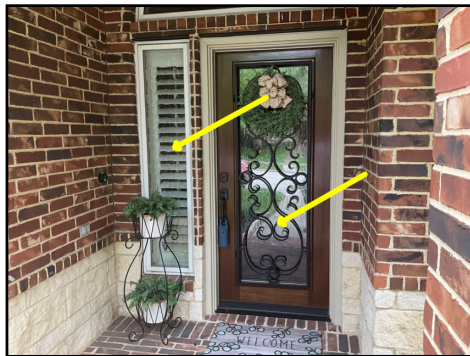
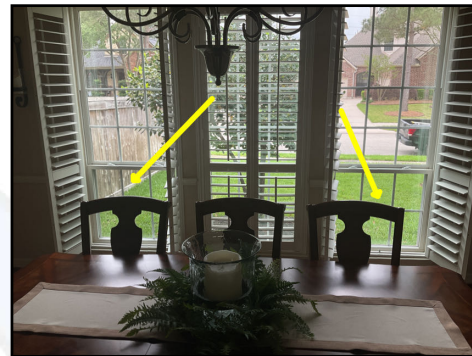
Safety glass not present at front door and side (Left) Window not opening properly; (Right) lite windows **Window not staying open**

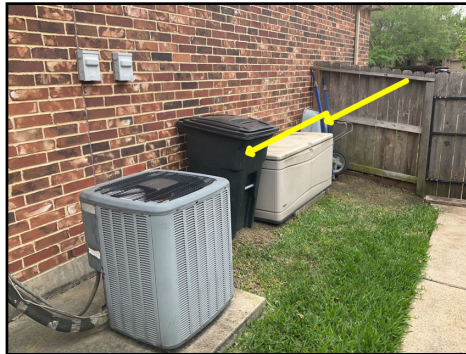
Various storage/debris observed across left exterior wall

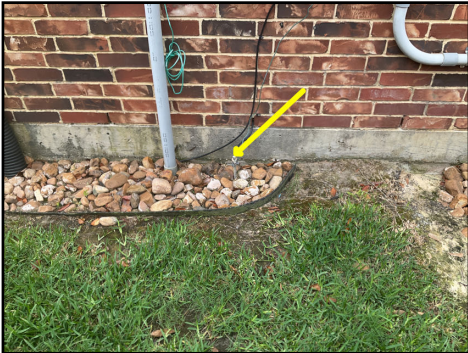
Ground rod does not appear to be fully installed into soil and/or improper ground clamp observed @ this time.

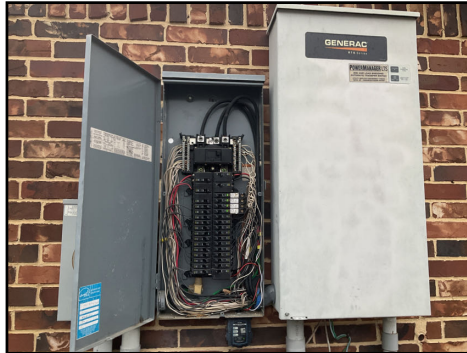
Disconnect/distribution panel inspected

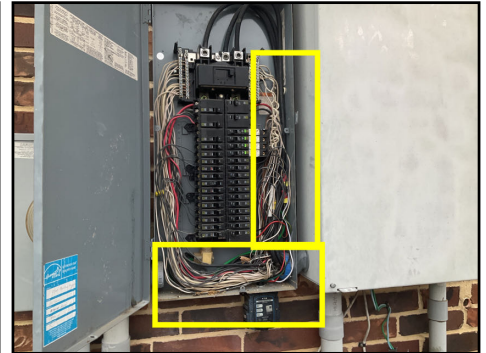
Excessive/bundled wiring noted inside panel

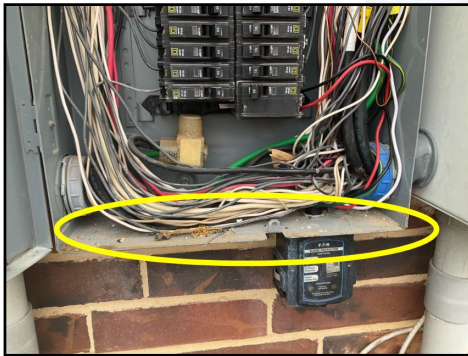
Some level of corrosion and/or animal droppings was observed in the service panel

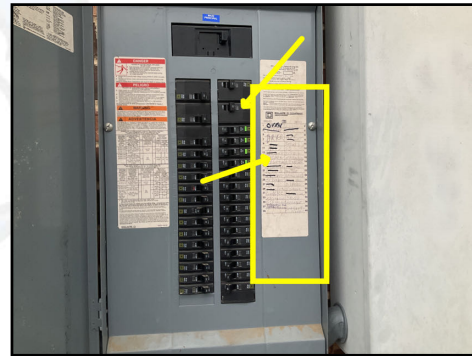
(Rectangle) Some breaker labeling crossed out along panel trim (A/C breaker appears to be under and over amped if breakers correspond (Arrows) from condenser to labeled breakers. Recommend an electrical contractor for further evaluation)

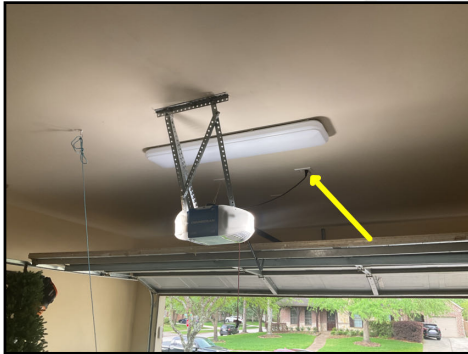
The GFCI (ground fault circuit interrupter) breaker not functional @ one or more location(s).

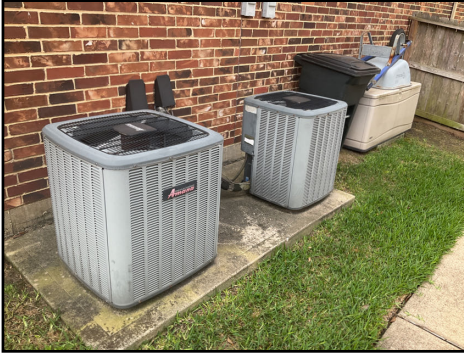
Left exterior condenser units inspected

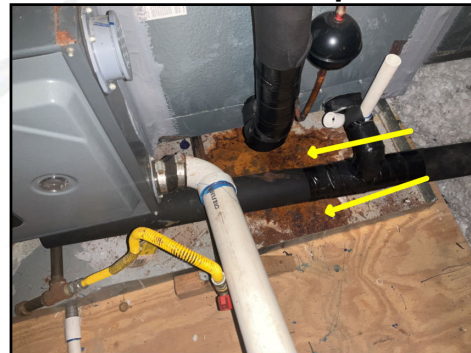
Significant rusting observed inside right attic pan

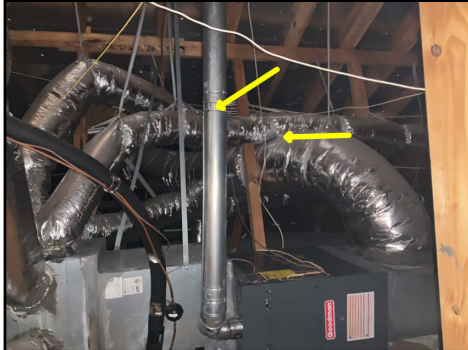
Ductwork in contact inside attic

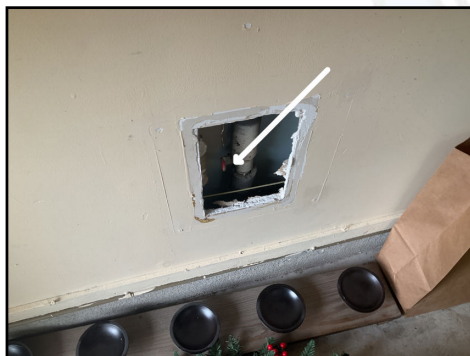
Water shutoff appears to be located along left interior wall

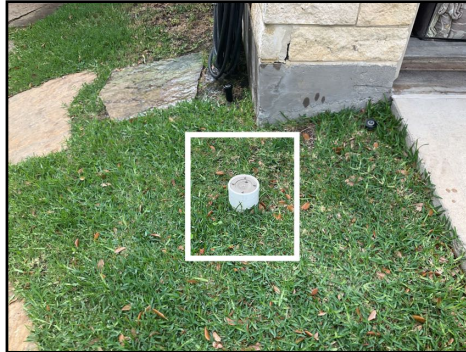
Sewer tap observed along front exterior

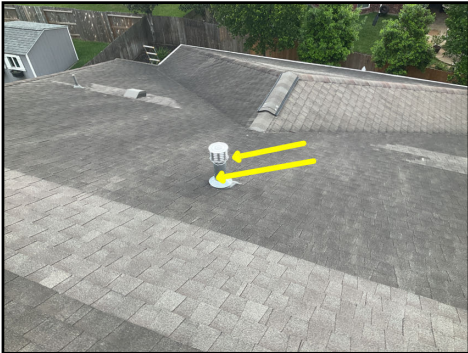
Sealant does not appear to be present around back flue piping (Piping does not appear to be proper height (3' above roof) per standards and recommend a plumbing contractor for further evaluation)

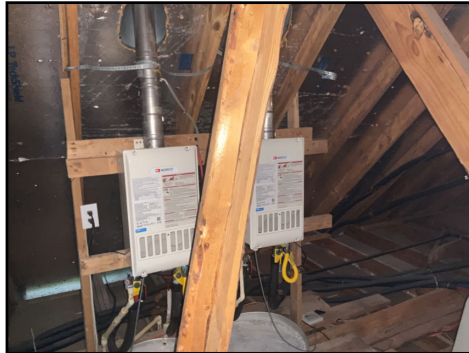
2 attic tankless water heaters inspected

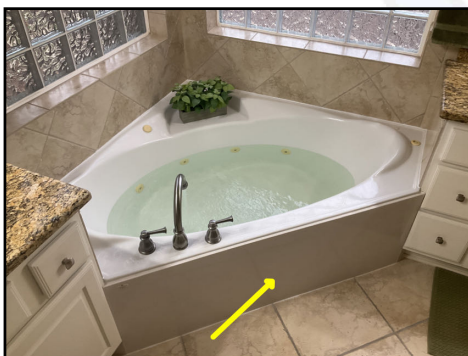
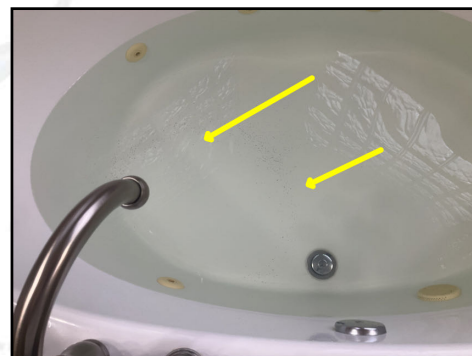
The hydromassage therapy equipment was located in the primary bathroom; (Arrow) Accessible panel not present for primary tub

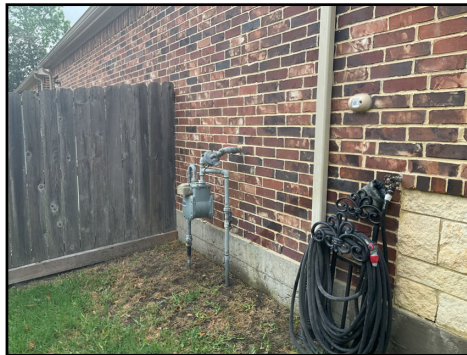
Gas meter located along left exterior

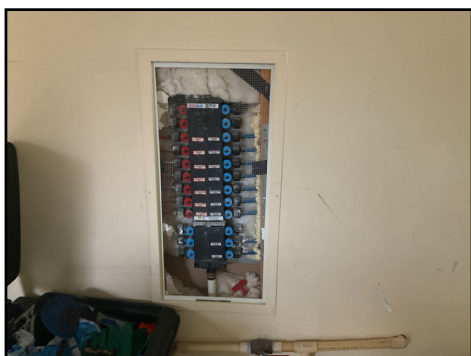
Left interior garage plumbing manifold inspected

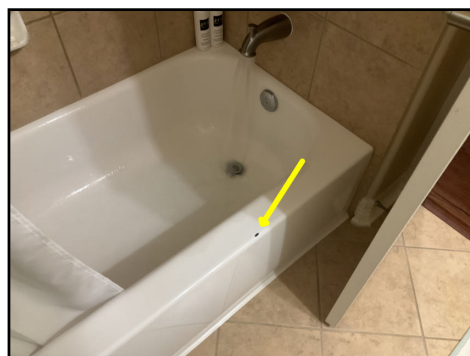
Gouged/chipped surface(s) observed across one or more interior tub surfaces.

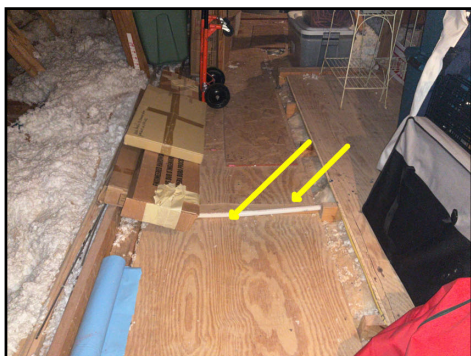
Drainage line appears over attic platform walkway (Safety/tripping hazard observed)

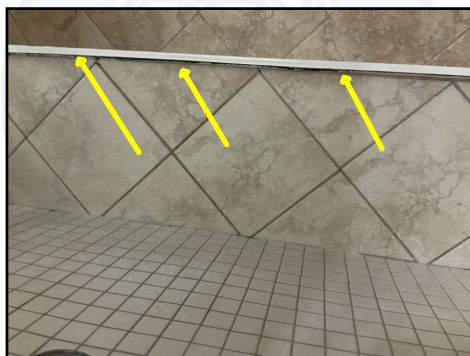
Damaged/organic growth observed along sealant under primary shower seat to wall

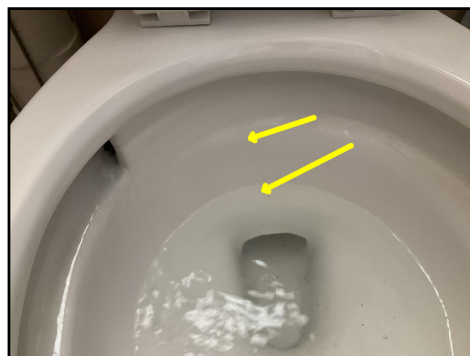
Hairline cracking appears t be present at right bathroom toilet

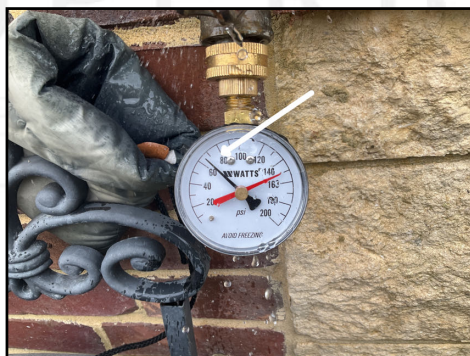
PSI measured between 66 - 70 range

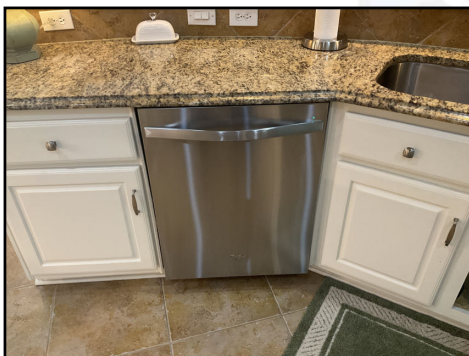
Kitchen dishwasher unit inspected

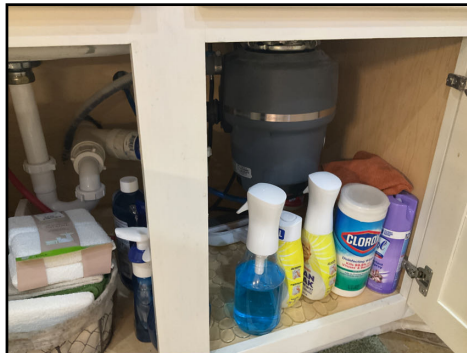
Kitchen sink disposer unit inspected

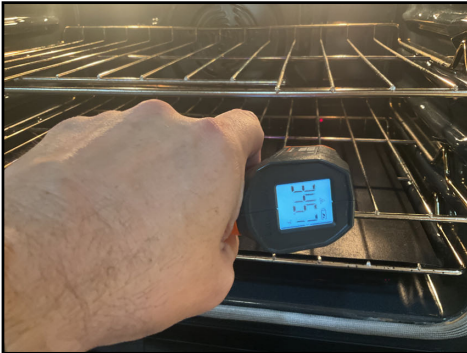
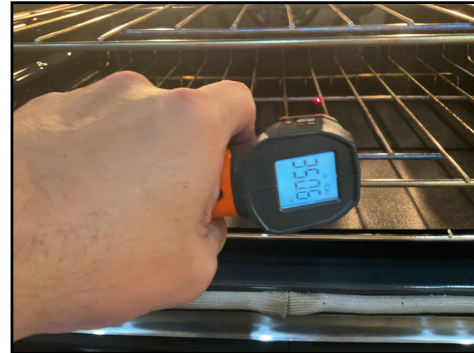
Upper oven unit temperature measured when set to 350 degrees

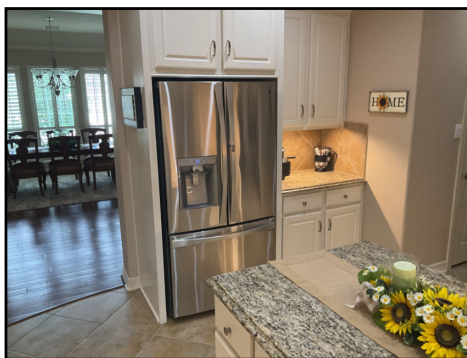
Kitchen refrigerator not part of the inspection

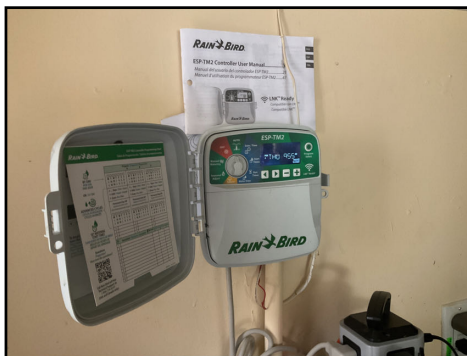
Interior garage console

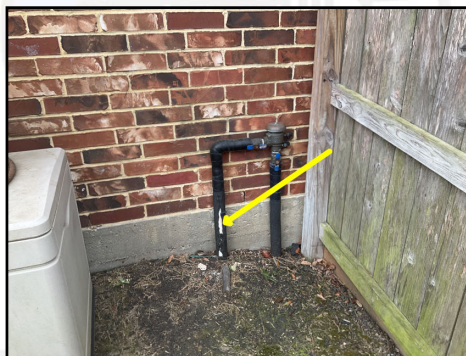
Damaged insulation observed around irrigation piping

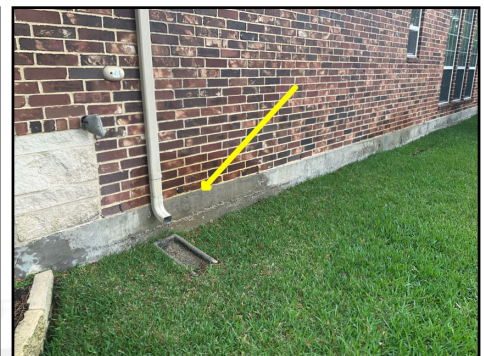
Various head(s) spraying along exterior wall(s).
