PROPERTY INSPECTION
REPORT

1214 Anystreet Avenue, Humble, TX 77338

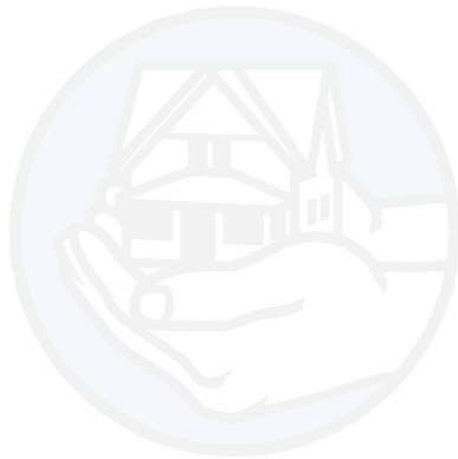
INTERNACHI® CERTIFIED
SUPERIOR
REAL ESTATE INSPECTIONS
— PLLC —

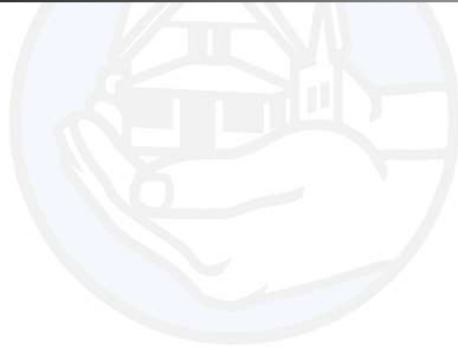
INTERNACHI® CERTIFIED
SUPERIOR
REAL ESTATE INSPECTIONS
— PLLC —

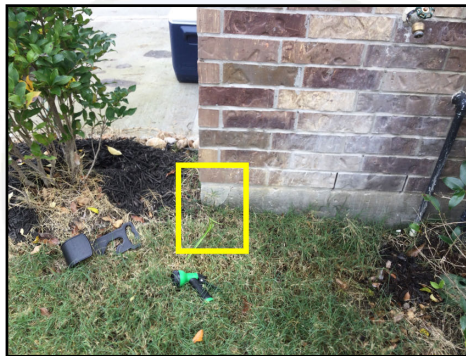
Foundation corner cracking observed along one or more location(s); (Cracking did not appear to have any bearing upon foundation performance during inspection across all applicable locations)

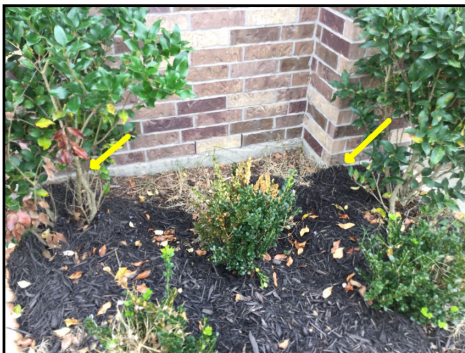
Soil to brick contact observed along front exterior wall (Recommend 4" or more slab exposure across all soil to brick areas per compliance)

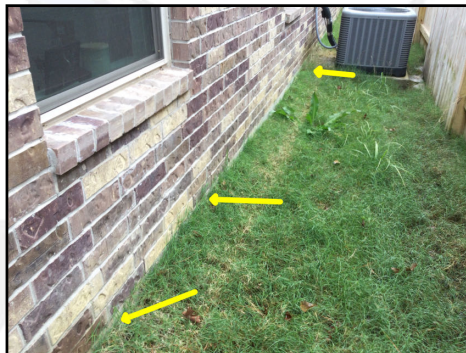
Soil to brick/siding contact observed along right exterior

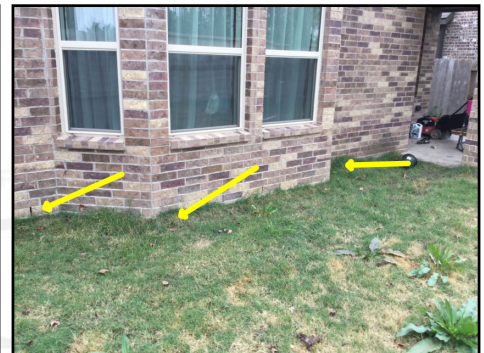
Soil to brick/siding contact observed along back exterior

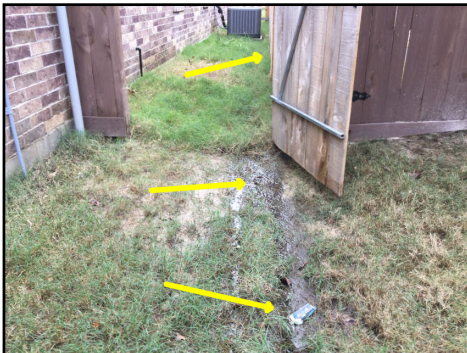
Water settling area(s) observed along one or more location(s) @ time of inspection (Recommend a landscape contractor for further evaluation across all areas to eliminate water settling)

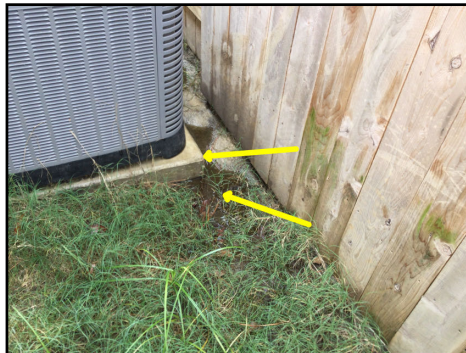
Water settling area(s) observed along right exterior swale.

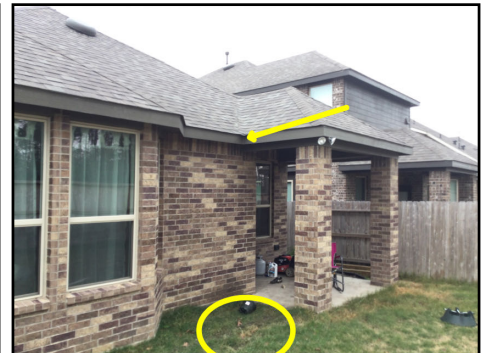
Water settling observed along back exterior soil under roofing valley

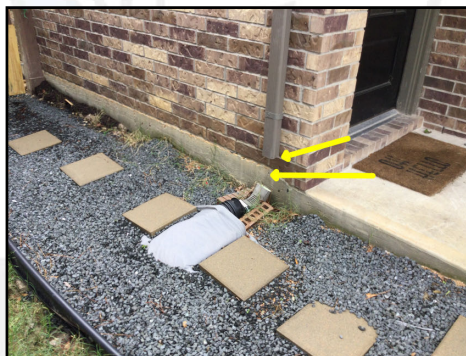
Gutter downspout elbow piping disconnected from vertical unit

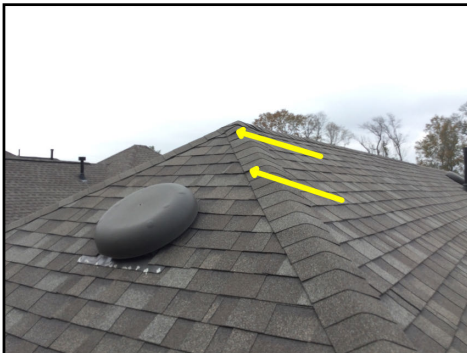
Lifted shingles observed along back left exterior

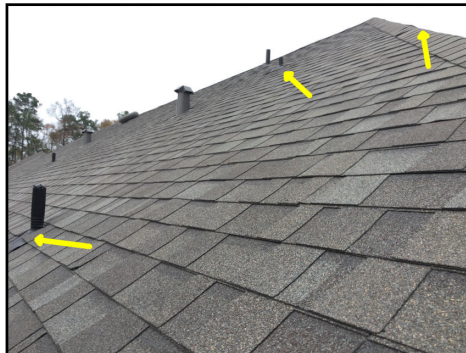
Lifted vent trim/shingles observed along right exterior

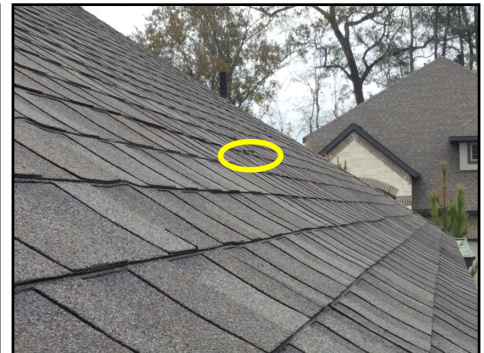
Debris/nails observed atop several exterior covering locations

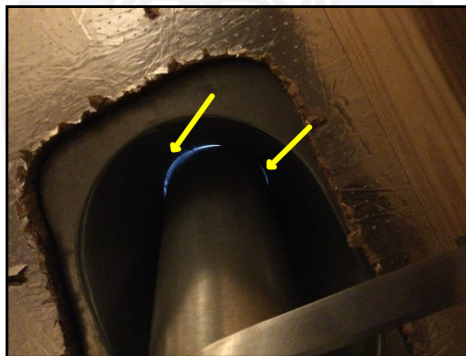
Daylight exposure observed around furnace flue piping penetration

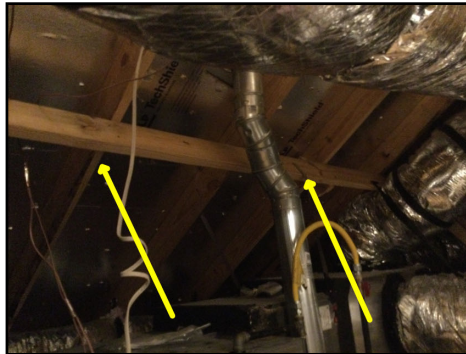
Purlin bracing not present across every 4' over attic furnace area (Recommend a building/framing contractor for further evaluation)

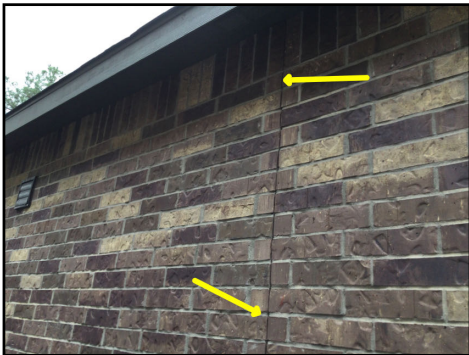
Expansion joint missing sealant along left exterior wall

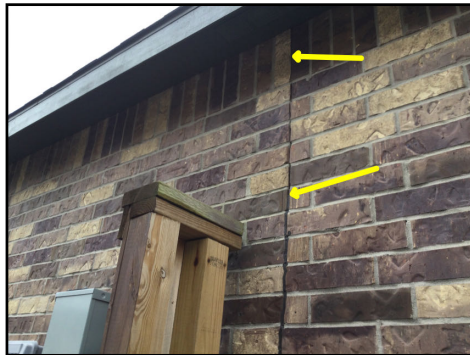
Areas along right expansion joint not sealed

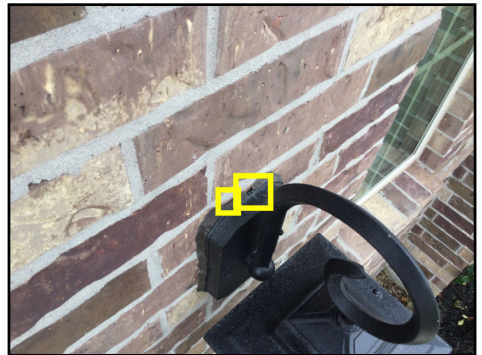
Exposed openings observed along front exterior fixture base

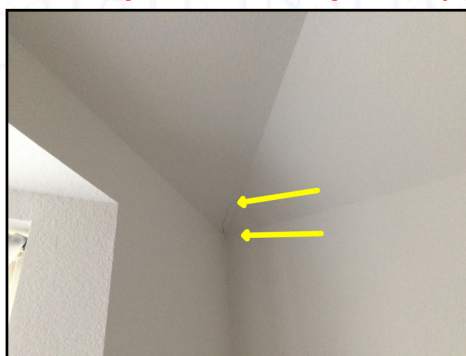
Drywall cracking observed along primary bedroom sloped scelling (There did not appear to be any signs of moisture intrusion or areas did not appear to be foundation related in my opinion)

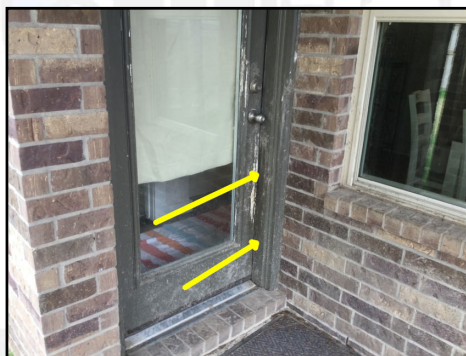
Damaged weather stripping observed along back door location

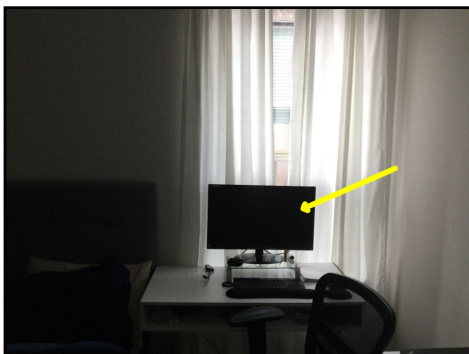
Right bedroom window inaccessible

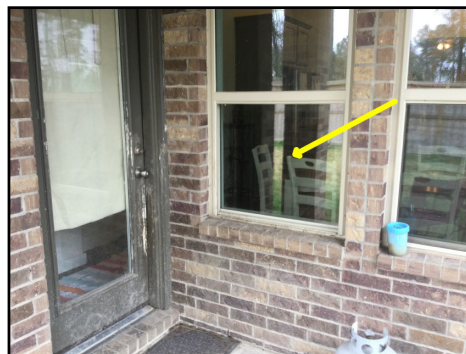
Window screen missing along breakfast room location

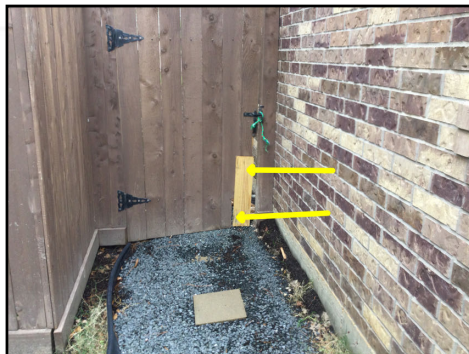
Damaged fence pickets observed along gate

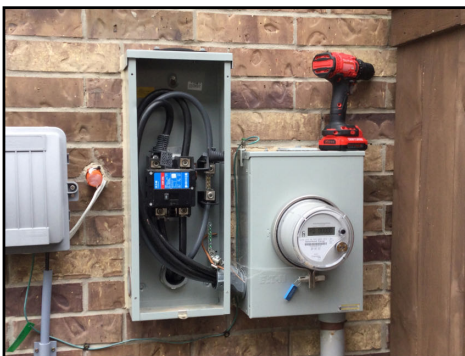
Right exterior disconnect panel inspected

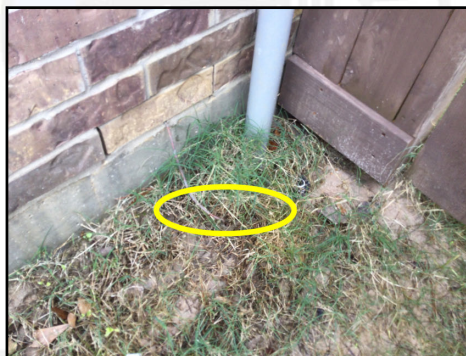
Ground rod does not appear to be fully installed into soil and/or improper ground clamp observed @ this time.

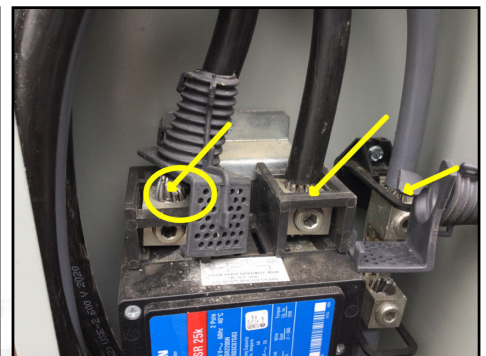
(Arrows) Anti-oxidant paste not present around service aluminum cables; (Oval) Cut/damaged wiring strands observed (Recommend an electrical contractor for further evaluation)

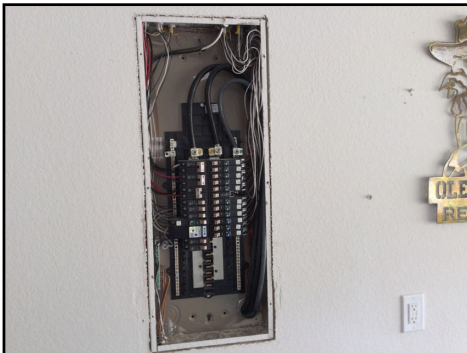
Distribution panel inspected inside garage

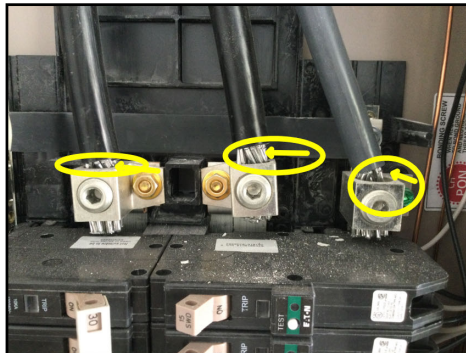
(Arrows) Anti-oxidant paste not present around service aluminum cables; (Oval) Cut/damaged wiring strands observed (Recommend an electrical contractor for further evaluation)

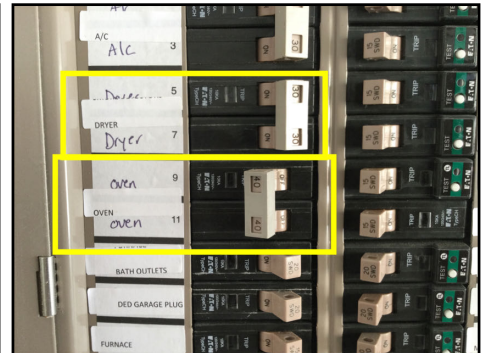
Oven and dryer breakers do not appear to be GFCI protected (Recommend an electrical contractor for further evaluation. FYI, Oven breaker was set to the off position prior to evaluation)

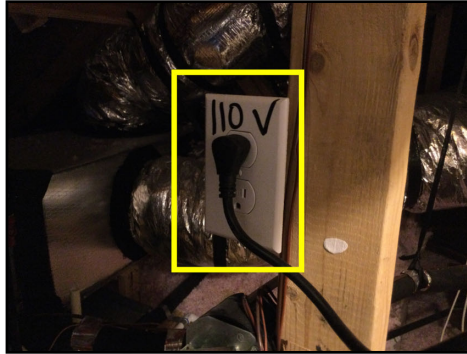
GFCI protection not established at attic support

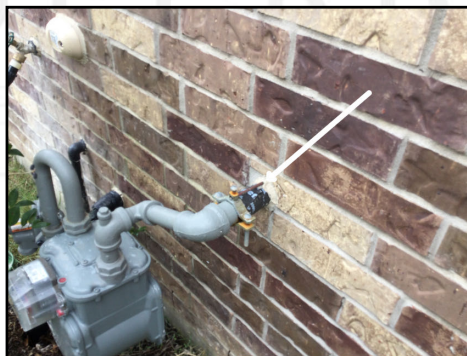
Bonding appears to be present around gas meter piping (This and bonding at grounding rod appeared to be only bonding visible during the inspection)

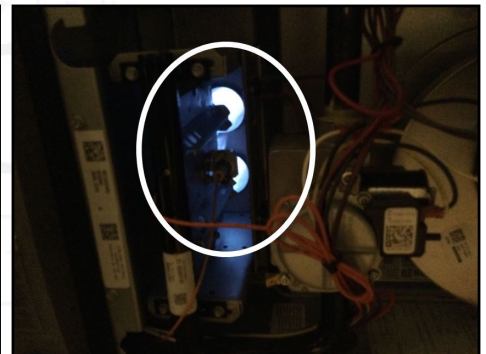
Blue flames observed inside burner compartment

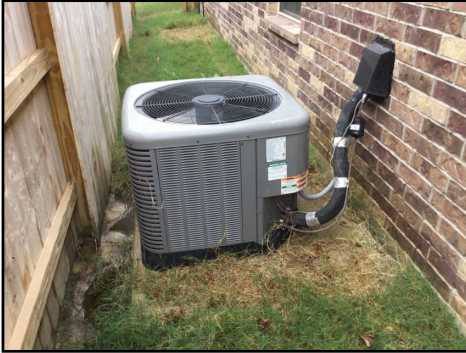
Right exterior condenser unit inspected

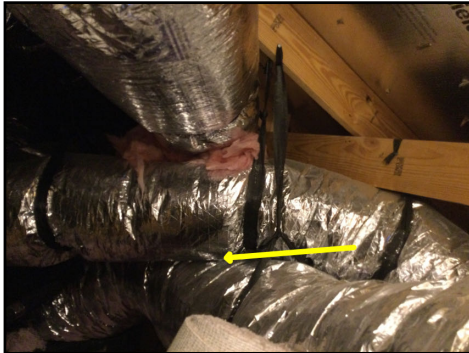
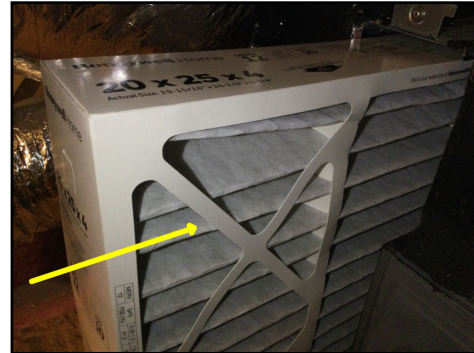
Various supply/return ductwork inside attic in contact with each other. Separator not present across from attic HVAC unit, as above connection appeared to have separator)

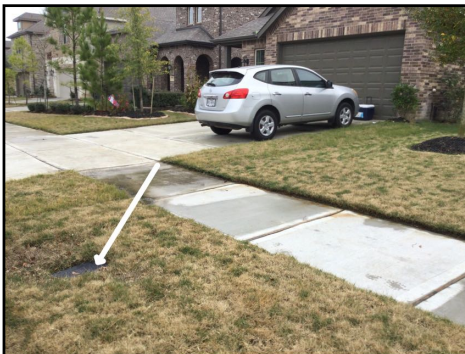
Water meter located along front right exterior

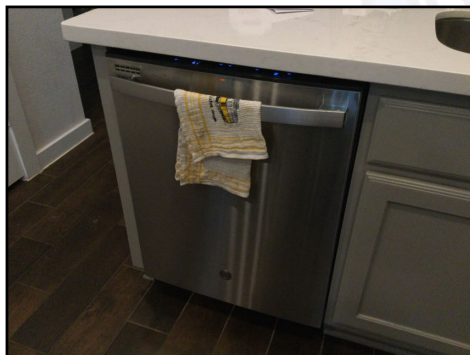
Kitchen dishwasher unit inspected

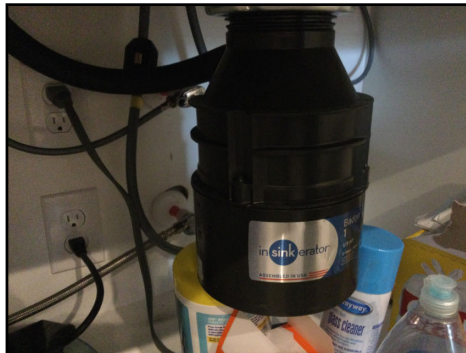
Unit was operational and functional at the time of the inspection.

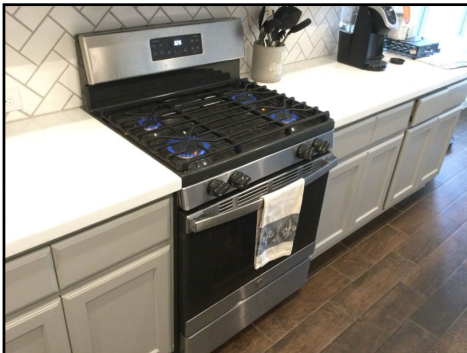
Kitchen oven/cooktop unit inspected

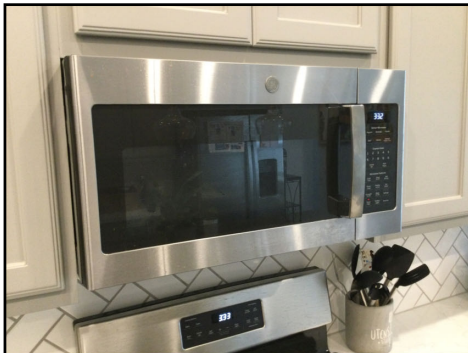
Kitchen microwave unit inspected

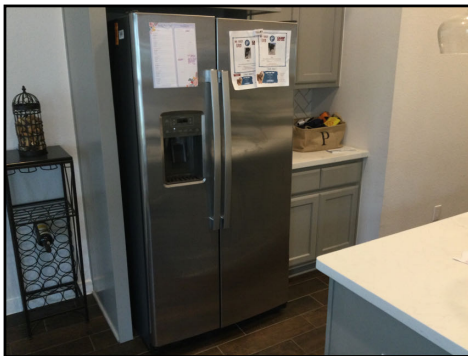
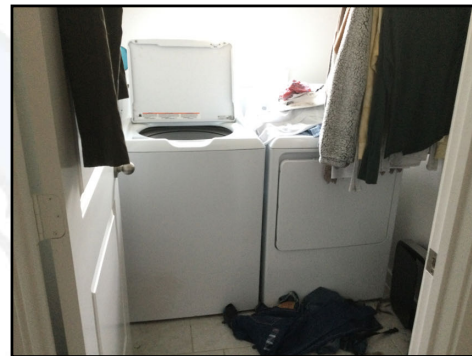
Kitchen refrigerator not part of the inspection Utility room washer/dryer appliances not part of the inspection

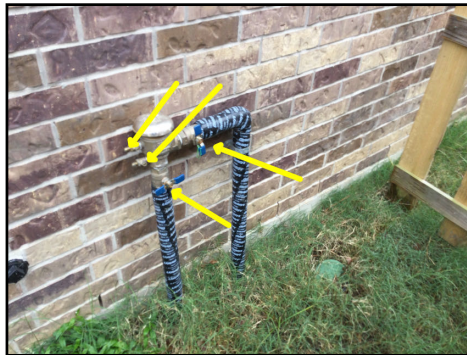
Irrigation valves were set to the off position prior to the inspection (Recommend further evaluation by an irrigation contractor)

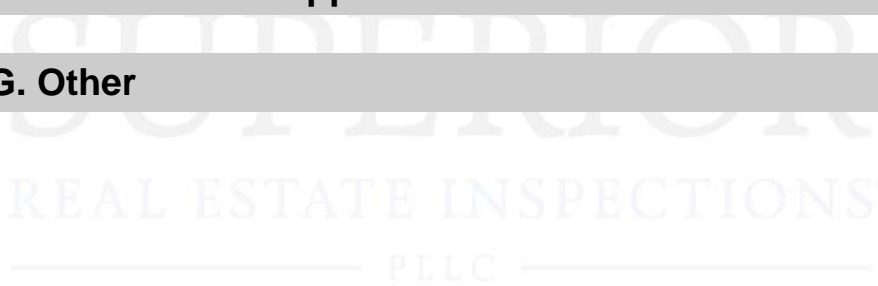
- B. Swimming Pools, Spas, Hot Tubs, and Equipment**
- C. Outbuildings**
- D. Private Water Wells (A coliform analysis is recommended)**
- E. Private Sewage Disposal Systems**
- F. Other Built-In Appliances**
- G. Other**
