PROPERTY INSPECTION  
**REPORT**

**4321 Sample Drive, Cypress, TX 77429**

DATE OF INSPECTION: 2/21/2022

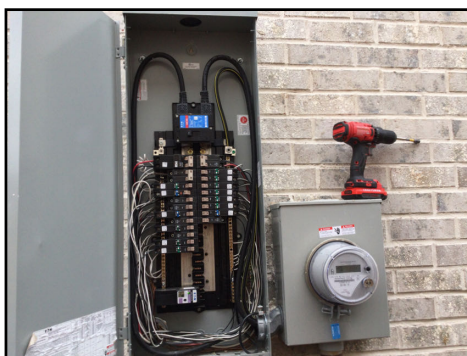
Arc-fault breakers **{AFCI}** did not appear function properly across one or more location(s).

*Right exterior distribution/disconnect panel inspected*

**Note: Beginning in 2008; AFCI breakers are required in the panel for 15A/20A branch circuits providing power to family rooms, dining rooms, living rooms, libraries, dens, bedrooms, sunrooms, recreation rooms, closets and hallways. ARCI breakers provide fire protection by opening the circuit when an arcing fault is detected. Breaker labeled "Washer" would not reset during evaluation. Recommend an electrical contractor for further evaluation. See picture below.**

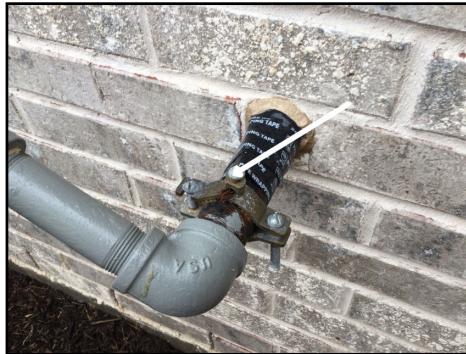
*Bonding/grounding observed around gas meter piping*

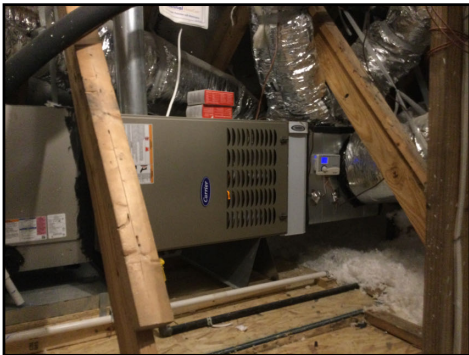
*Attic furnace unit inspected*

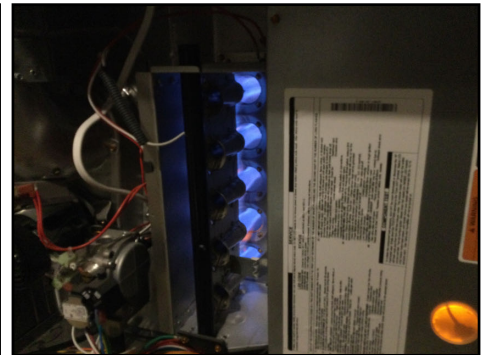
*Proper flame color observed along burner compartment*

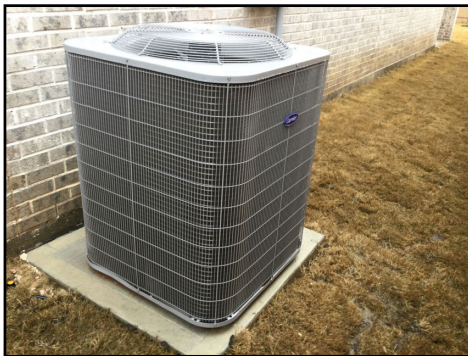
**Upstairs:** Supply - 74 degrees; Return - 76 degrees; delta T temperature - 2 degrees.

*Right exterior condenser unit inspected*

**Note:** Delta T temperature was not between 15 - 22 degrees @ time of inspection. Downstairs appeared to function properly, as upstairs thermostat cooling system was evaluated with a significant drop across differential. Unit(s) should be evaluated for compliance respective temperature prior to acceptance of property.

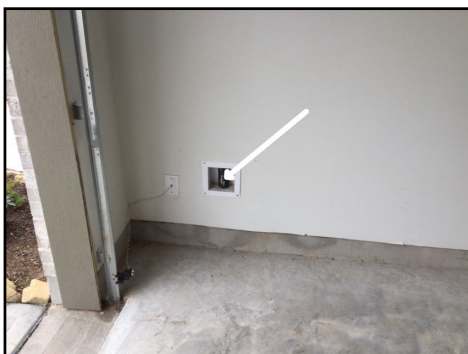
**Low water pressure observed along one or more interior location(s).**

**Water shutoff appears to be located along left interior garage wall**      **Upstairs Jack and Jill sink appears to have low water pressure**

**Note:** Various water sources appeared to have low pressure @ master & hall bath locations. All areas should be evaluated for proper functional flow/pressure across these areas. This should be evaluated prior to acceptance of property.

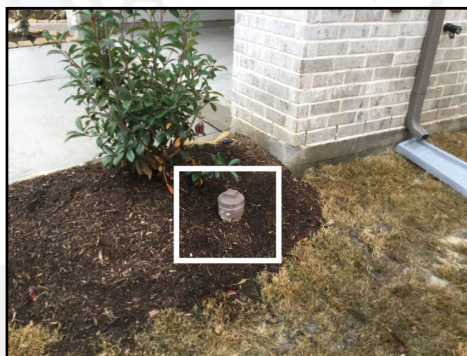
**Note:** The exterior main clean out was located @ the front of the structure. For observatory purposes only. See picture below.

*Sewer tap observed along front exterior*

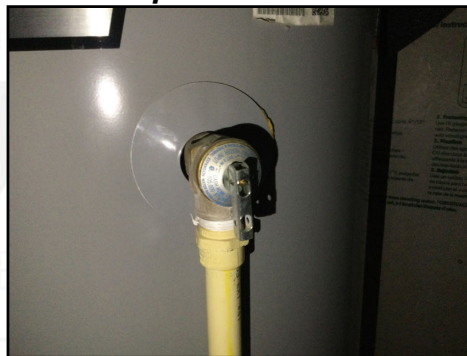
TPR (Temperature Pressure Relief) valve not accessed due to potential liability concerns.

TPR drainage lines not evaluated due to potential liability concerns

Note: Any home occupied and/or if valve is compromised, in accordance with, any potential malfunction and/or harm to dwelling is not evaluated. Proper evaluation should be done through a licensed plumber.

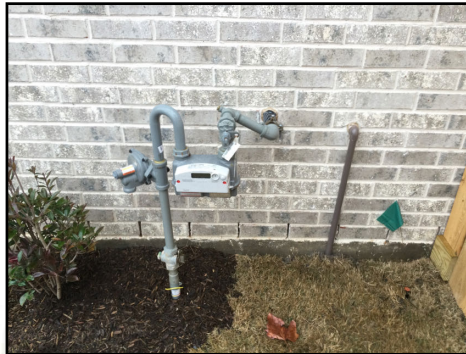
Bonding/grounding appeared to be set along gas meter piping during inspection.

*Gas meter located along right exterior*

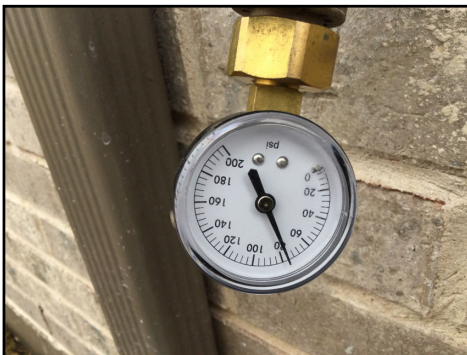
*PSI appears to be within 71 - 75 range*

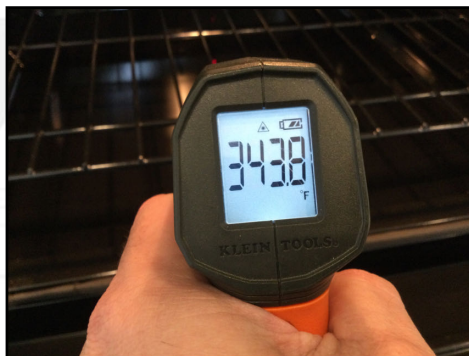
***Temperature measured inside oven when set to 350 degrees***

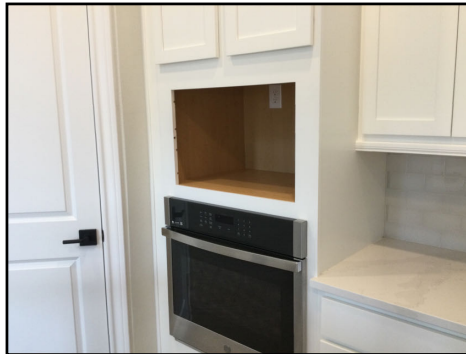
*Microwave unit not present during inspection*

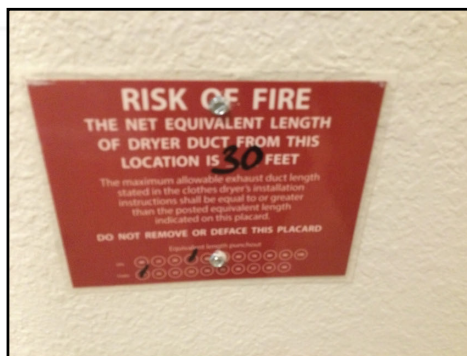
The dryer exhaust vent is required to terminate at the exterior of the structure. The vent pipe should not exceed {25 ft} for electric dryers and typically {35 ft} for gas units. Metal ducting is recommended and there should be no screws penetrating the duct that may collect lint. The dryer vent should terminate outside with a backdraft damper and no screens.

Note: The vent pipe should not exceed {25 ft} for electric dryers and typically {35 ft} for gas units. Metal ducting is recommended and there should not be screws penetrating the duct that may collect lint. The dryer vent should terminate outside with a backdraft damper & no screens. Piping length should be evaluated by an HVAC contractor. See picture(s) below.
